## Product & Application FAQ

### **Question: What causes BAND-IT® Jr. clamps to break during installation?**

FAQ- 101  
Issued 06/05

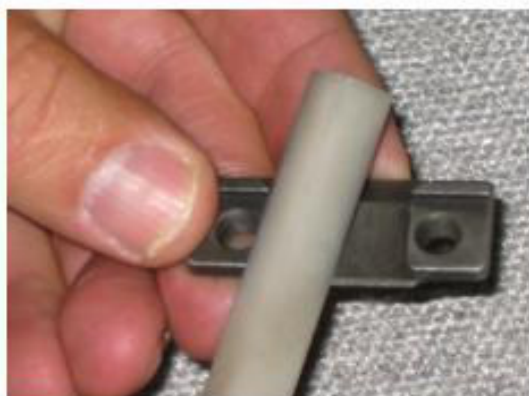
Hand polishing cutter blade with a fine stone.

- Regular maintenance of these parts includes examination of the leading edge condition and wear of the Cutter Blade.
- Steel shavings and material buildup will result from normal day-to-day clamp installation. Shavings and foreign material should be removed from the cutter blade leading edge by hand polishing with a fine stone. Polish all points of contact with the clamp without altering the part's surface dimensions. A #2 India stone works well for this procedure.
