## Product & Application FAQ

### **Question: What causes BAND-IT® Jr. clamps to break during installation?**

FAQ-101  
Issued 06/05

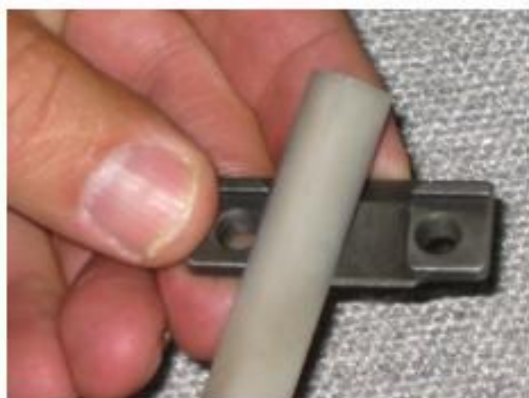
Hand polishing cutter blade with a fine stone.

- Regular maintenance of these parts includes examination of the leading edge condition and wear of the Cutter Blade.
- Steel shavings and material buildup will result from normal day-to-day clamp installation. Shavings and foreign material should be removed from the cutter blade leading edge by hand polishing with a fine stone. Polish all points of contact with the clamp without altering the part's surface dimensions. A #2 India stone works well for this procedure.
